THE STREAMBANK EROSION CONTROL
EVALUATION AND DEMONSTRATION ACT OF 1974
SECTION 32, PUBLIC LAW 93-251

Appendix G - Demonstration Projects on Other Streams, Nationwide
Volume 1 of 2

FINAL REPORT TO CONGRESS

APPENDIX G DEMONSTRATION PROJECTS ON OTHER STREAMS, NATIONWIDE

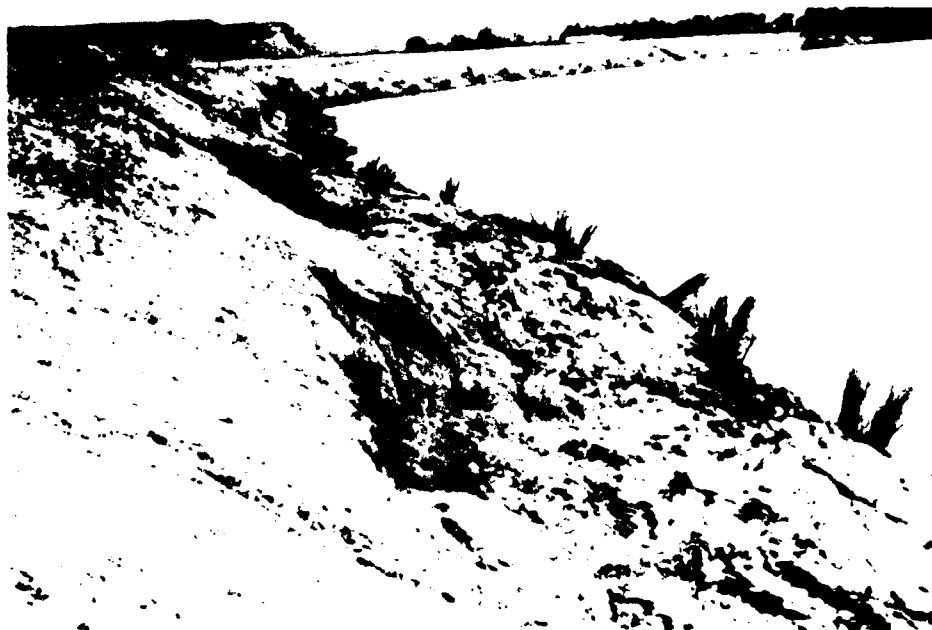
PHOTO 18. Five Months After Construction Looking
Upstream From Near Mid-Point of Project -
Note Slope Failure of Fill (Photo Taken
7 May 1981)

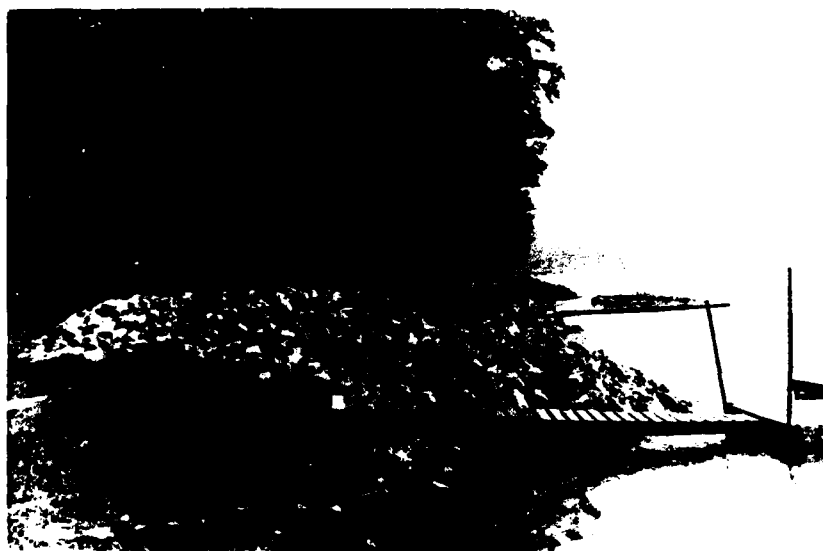
STATION 26+00 HARDPOINT
 27 JUNE 1980

ALLEGHENY RIVER
 WATTERSONVILLE, PA.
 DAMAGED HARDPOINT

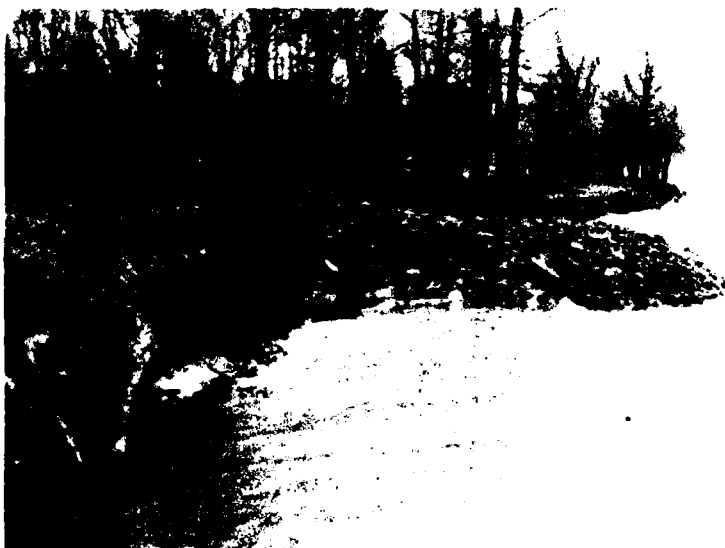
VIEW FROM STATION 31+00
NOTE ICE DAMAGE TO NOSE OF HARDPOINT
14 APRIL 1981

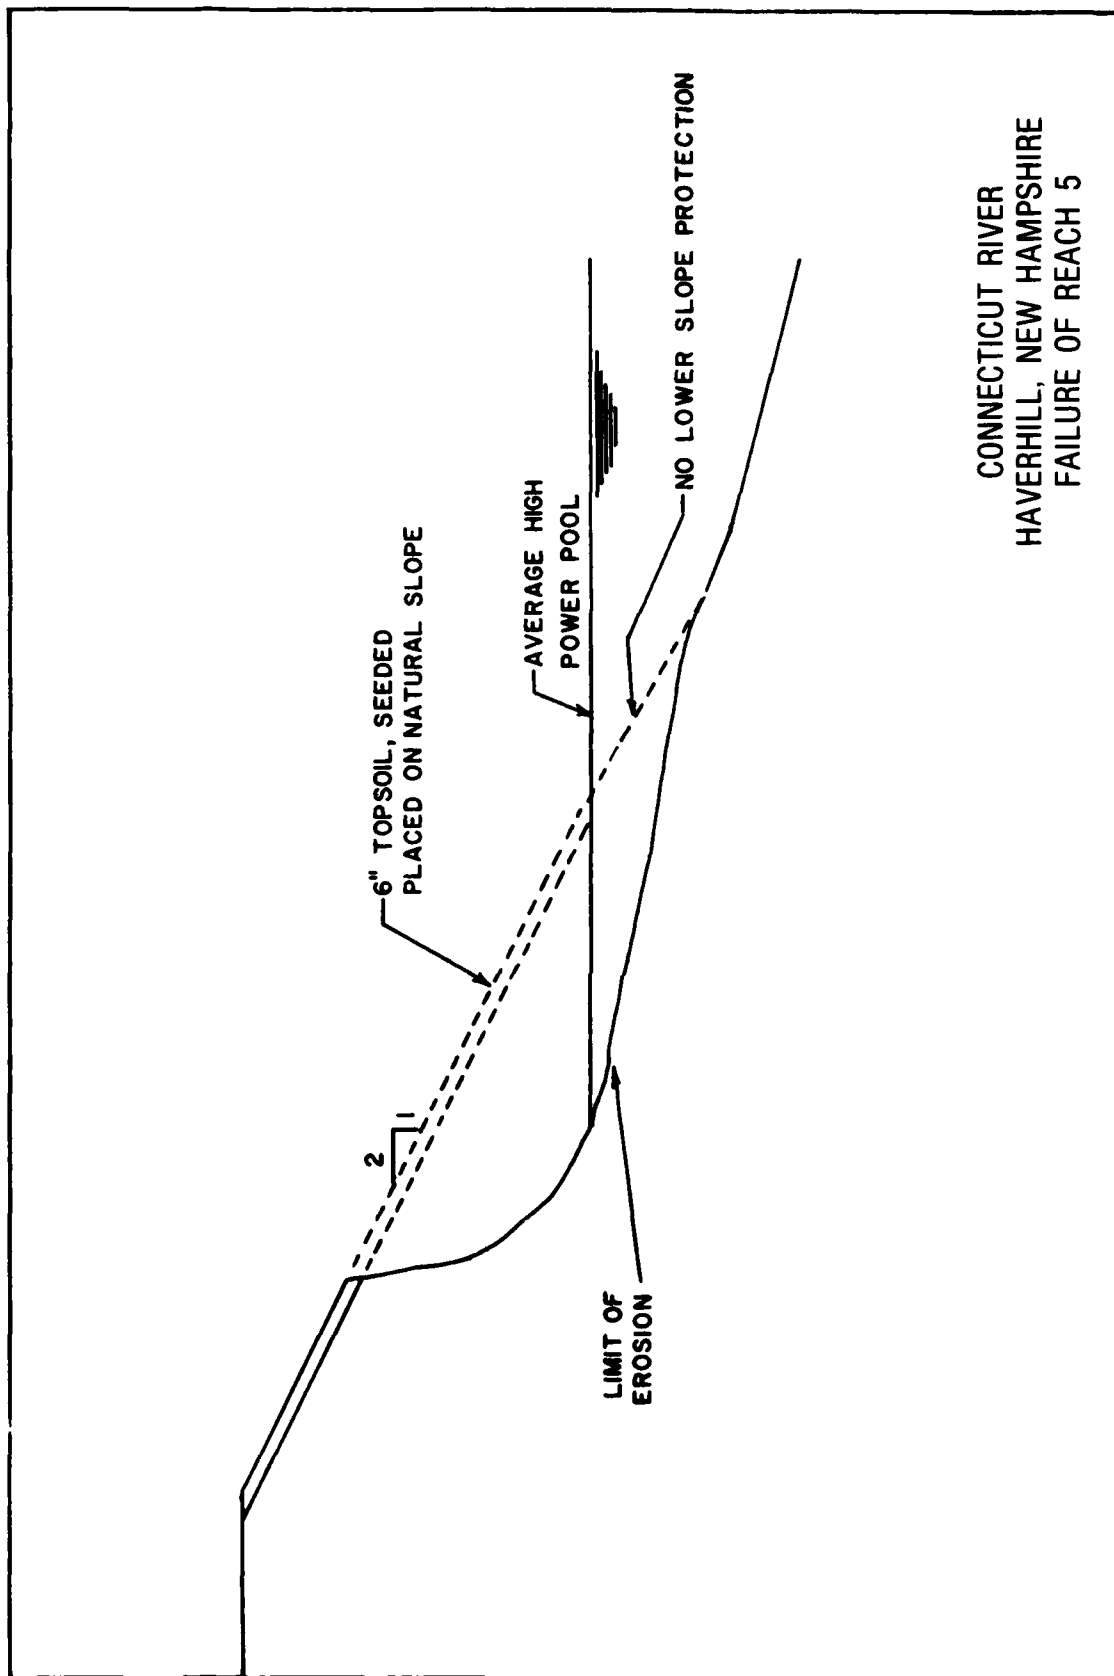
PLATE 14

CONNECTICUT RIVER
HAVERHILL, NEW HAMPSHIRE
FAILURE OF REACH 5
